# Corrosion Report

Equipment Location ID 0955-009-008  
Equip. Location Descrip. C-1100 LEVEL INSTRUMENTS

04/11/2011 TTWV	<b>INSPECTION PIPING ISOMETRIC</b>	
	<b>#9 ATMOSPHERIC COLUMN BOTTOMS</b>	
	<b>#4 CRUDE UNIT (PLANT 11)</b>	
	<b>DISTILLATION AND REFORMING AREA BUSINESS UNIT</b>	
<b>Z</b>	<b>0955-009-008</b>	REV SHT 4 1

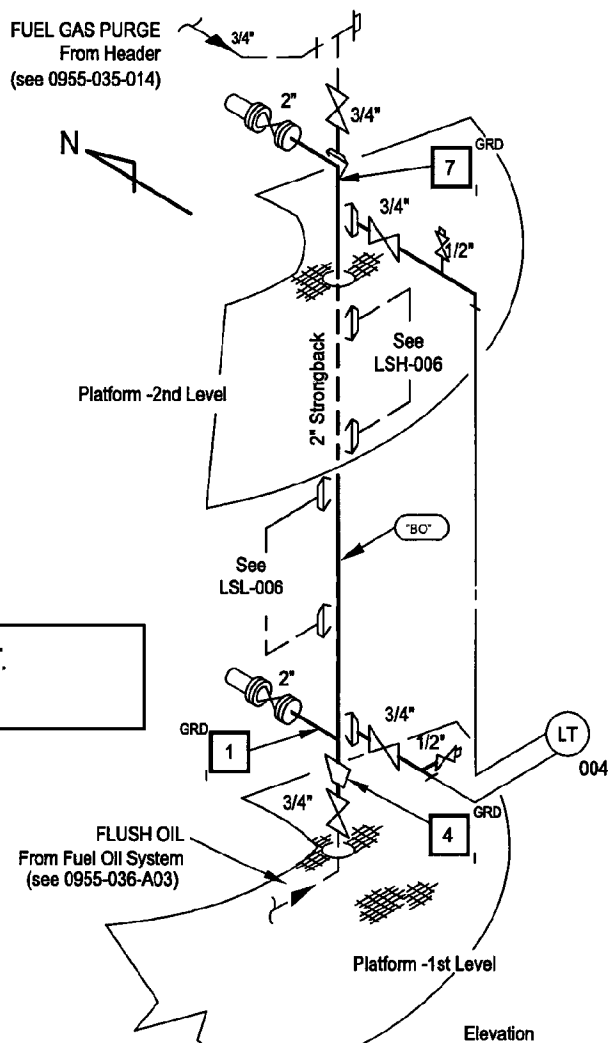
**C-1100 INSTRUMENTS**

**THIS IS A HOT CIRCUIT.**  
**ALL TML's TO BE RT'd**
